Maintenance Instruction

Problem: Truck not lowering

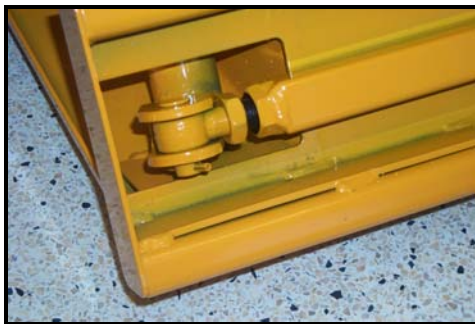
Photo 1 – jam nut loose

If the jam nut on either side has loosened and backed away as shown in the photo 1 below, it will prevent the complete rotation of the joint. To remedy this, the nut must be tightened up against the welded nut on the push bar (as in photo 2)

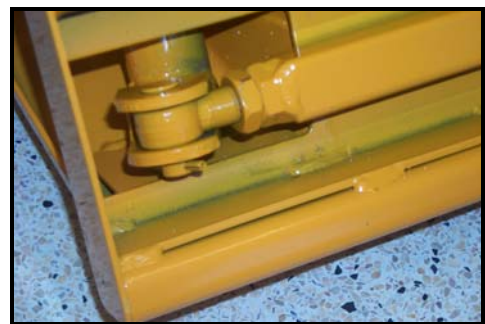
Photo 2 – tightened jam nut against welded nut
